ENVIRONMENTAL SURVEY REPORT
ASBESTOS, PCB, LEAD BASED PAINT AND RADON SURVEY
88TH Regional Support Command
MILWAUKEE (LOGAN), WI (WI-042)
USARC AND OMS
2373 SOUTH LOGAN AVENUE
MILWAUKEE, WI 53207

Adecco Technical Task Order DAY A000003029

Gil Bakshi, MA
President
05 October, 2005

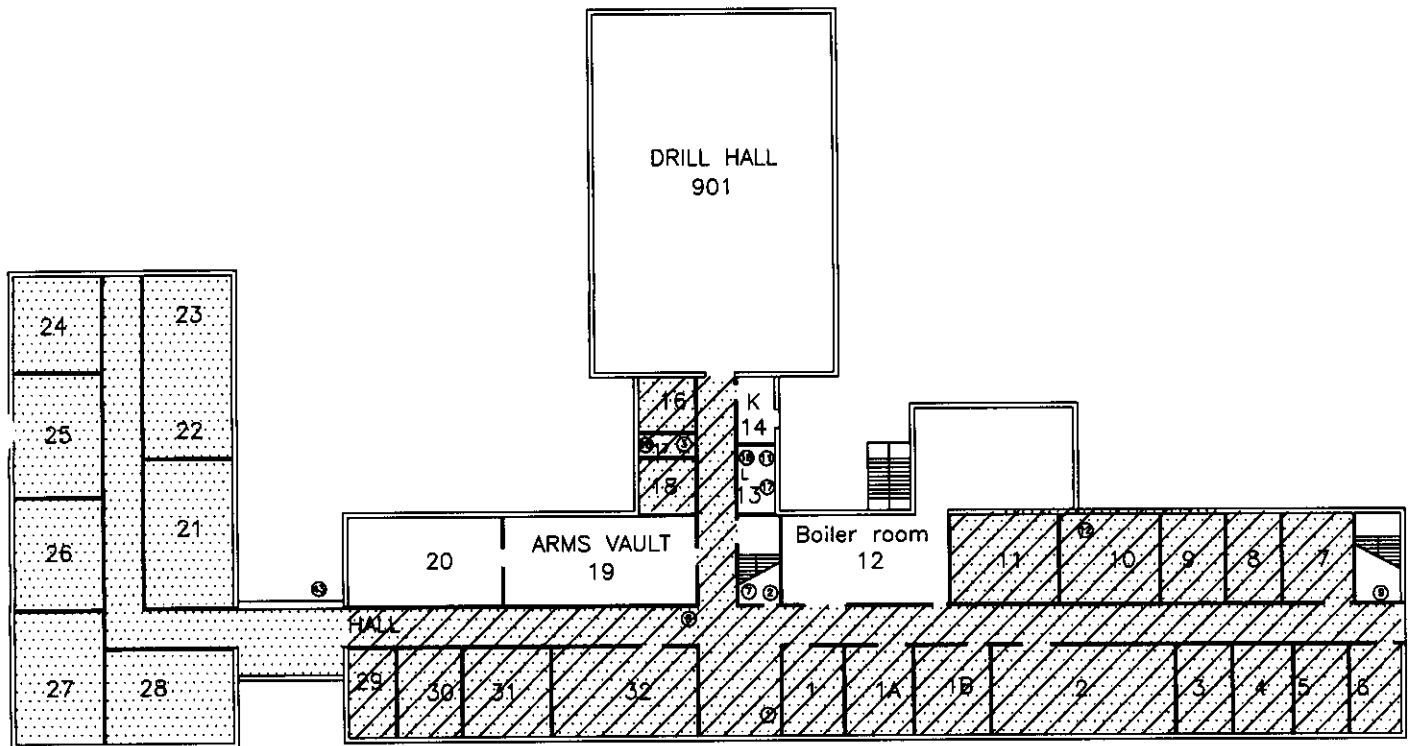
TSI ON PIPING LOCATED THROUGHOUT

TSI ON PIPE FITTINGS IS A HARD GRAY
MUD INSULATION LOCATED THROUGHOUT

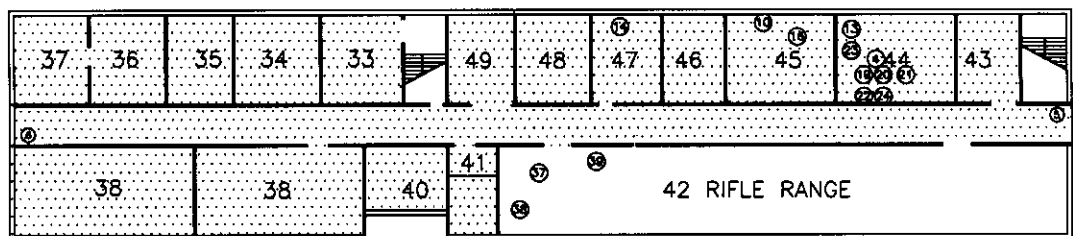
TSI ON PIPING LOCATED THROUGHOUT

TSI ON PIPE FITTINGS IS A HARD GRAY
MUD INSULATION LOCATED THROUGHOUT

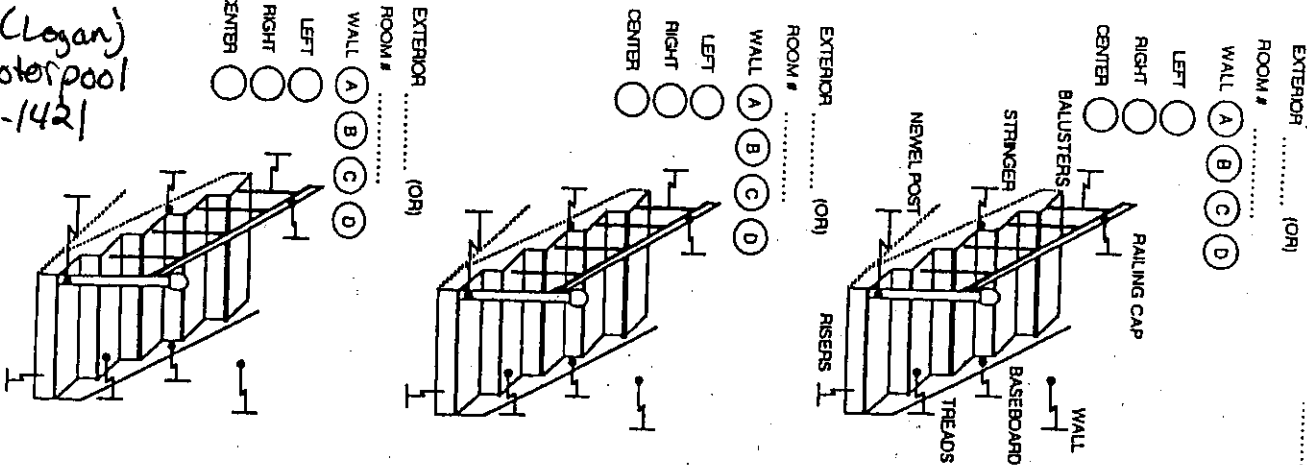
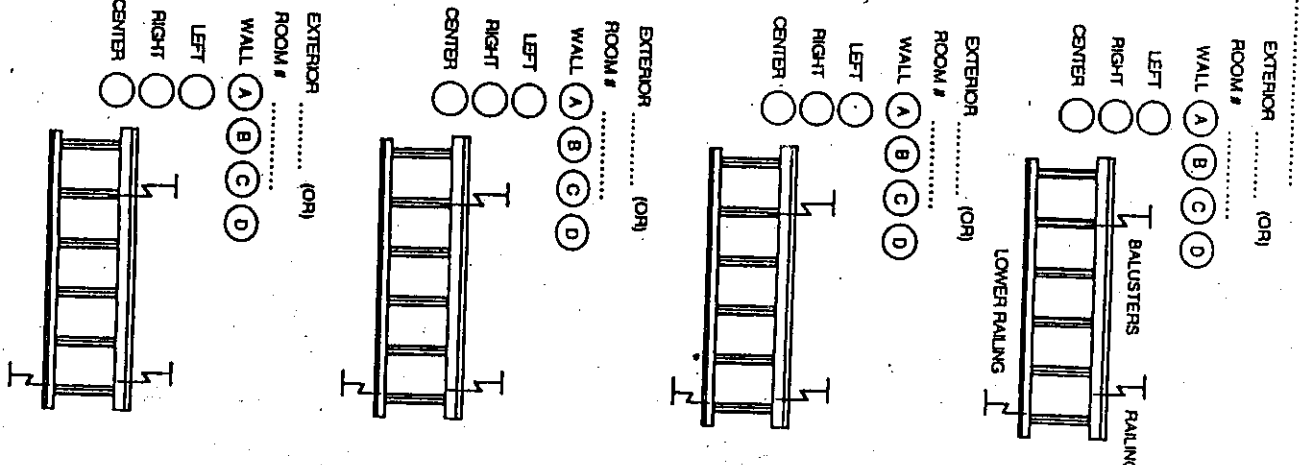
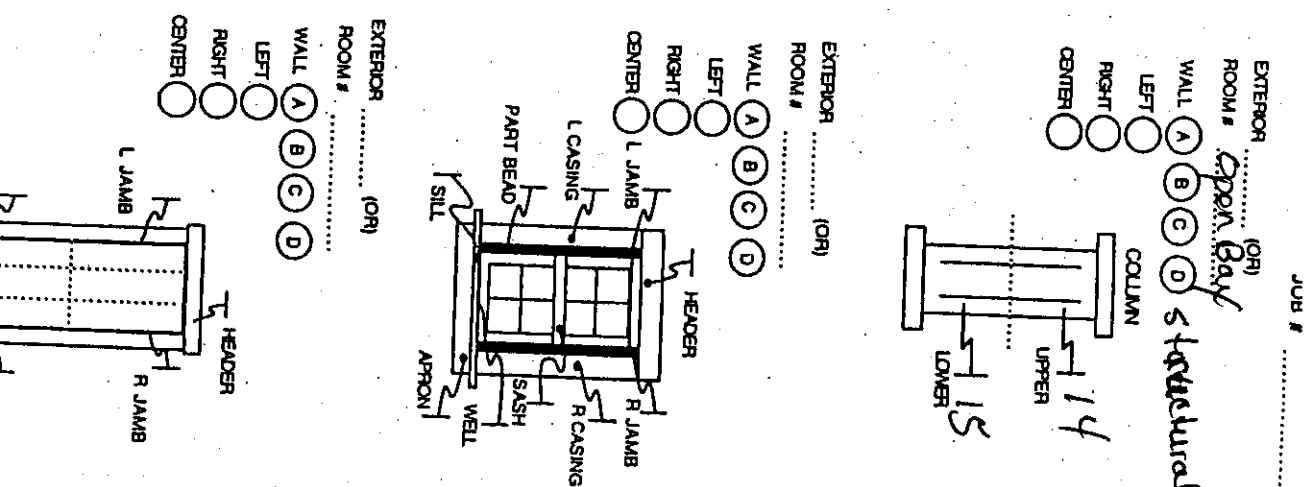
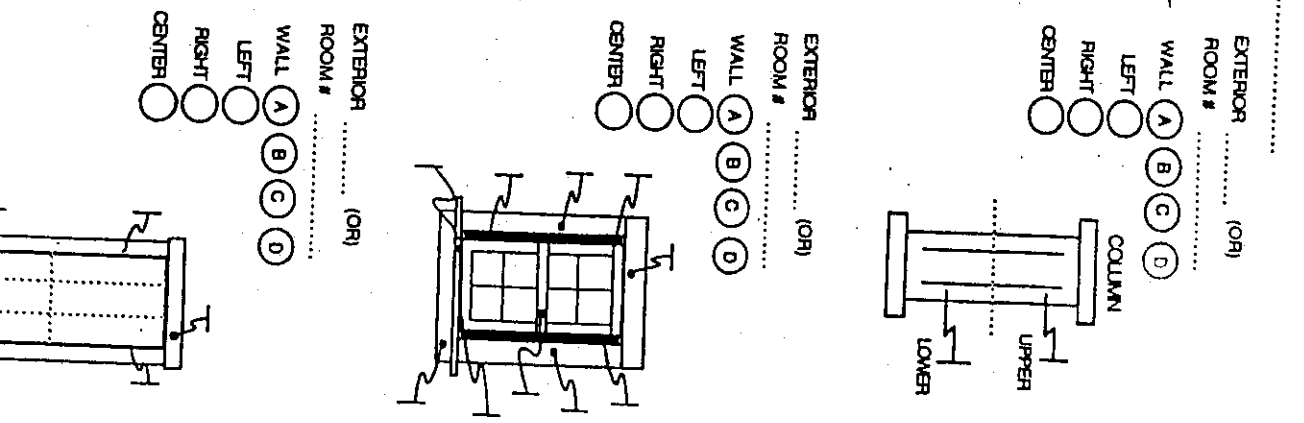
COMMENTS: Columnnaire grey finish with yellow 94 up
 and of wood substrate. Samples 14 and 15 are positive
 fair condition.

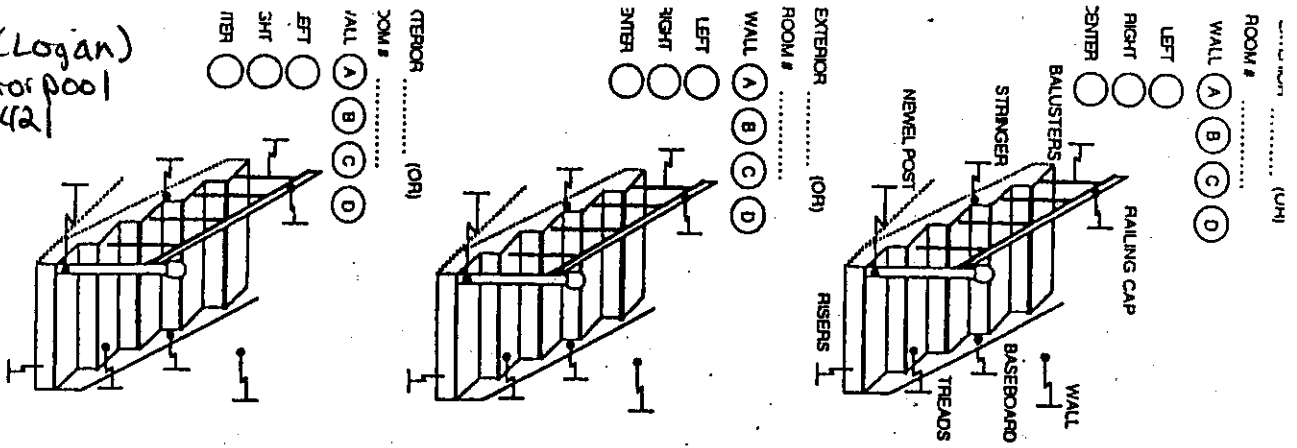
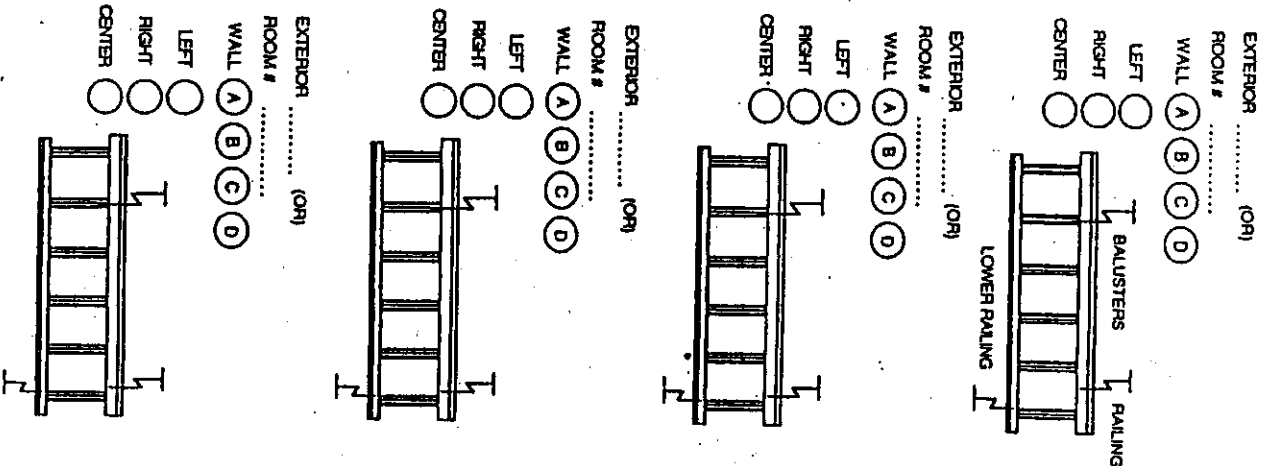
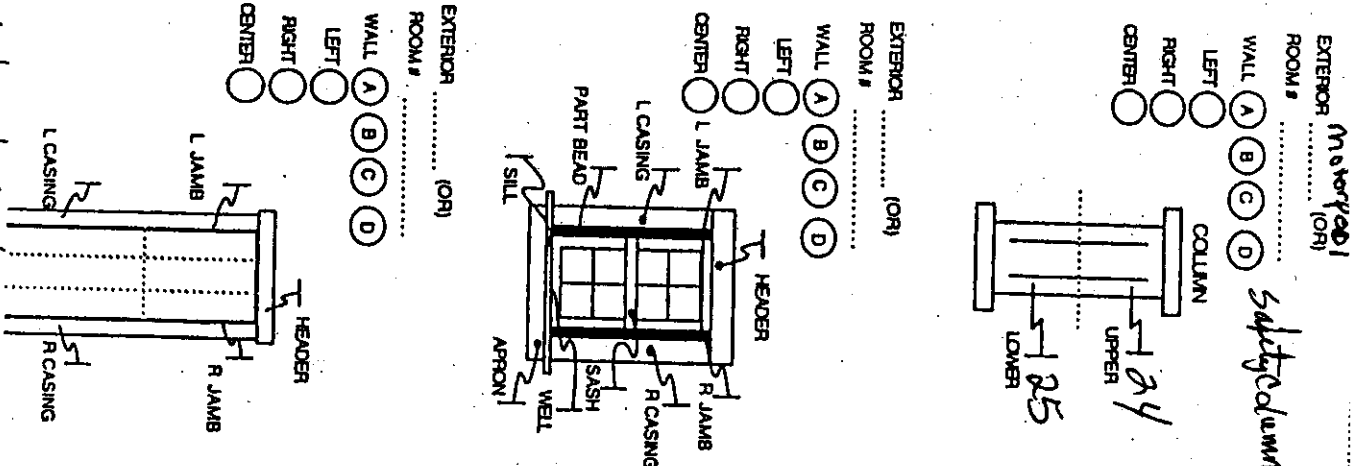
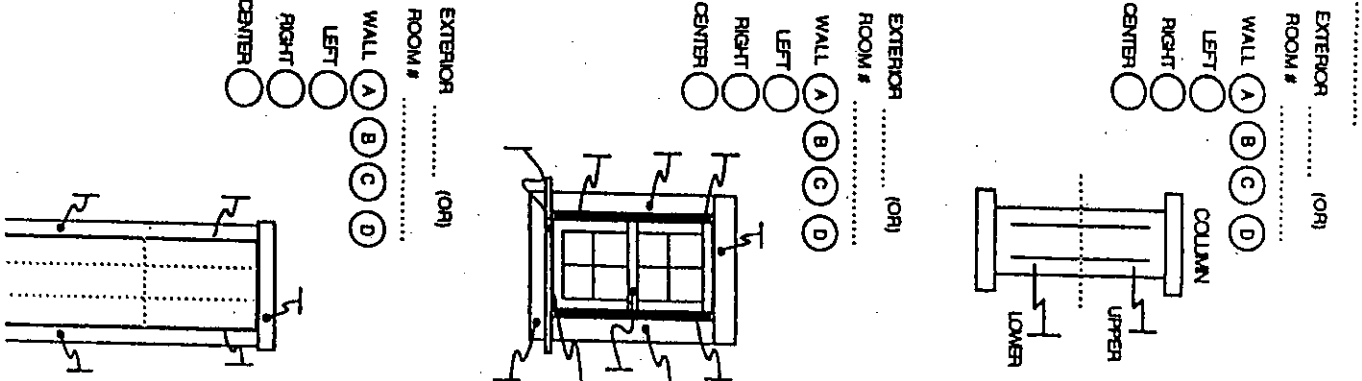
COMMENTS: Safety Column is yellow finish and of metal
Substrate. Safety Columns are in front of overhead doors
and samples attached as per positive and good condition
